Excavations at the Castillo de San Marcos  
St. Augustine, Florida:  
Archeological Data in Support  
of Architectural Stabilization

Kathleen Deagan  
Florida State University  
December 1980

Submitted to: The National Park Service Southeast Archeological  
Center  
Tallahassee, Florida  
NPS-FSU Contract #50 0090739

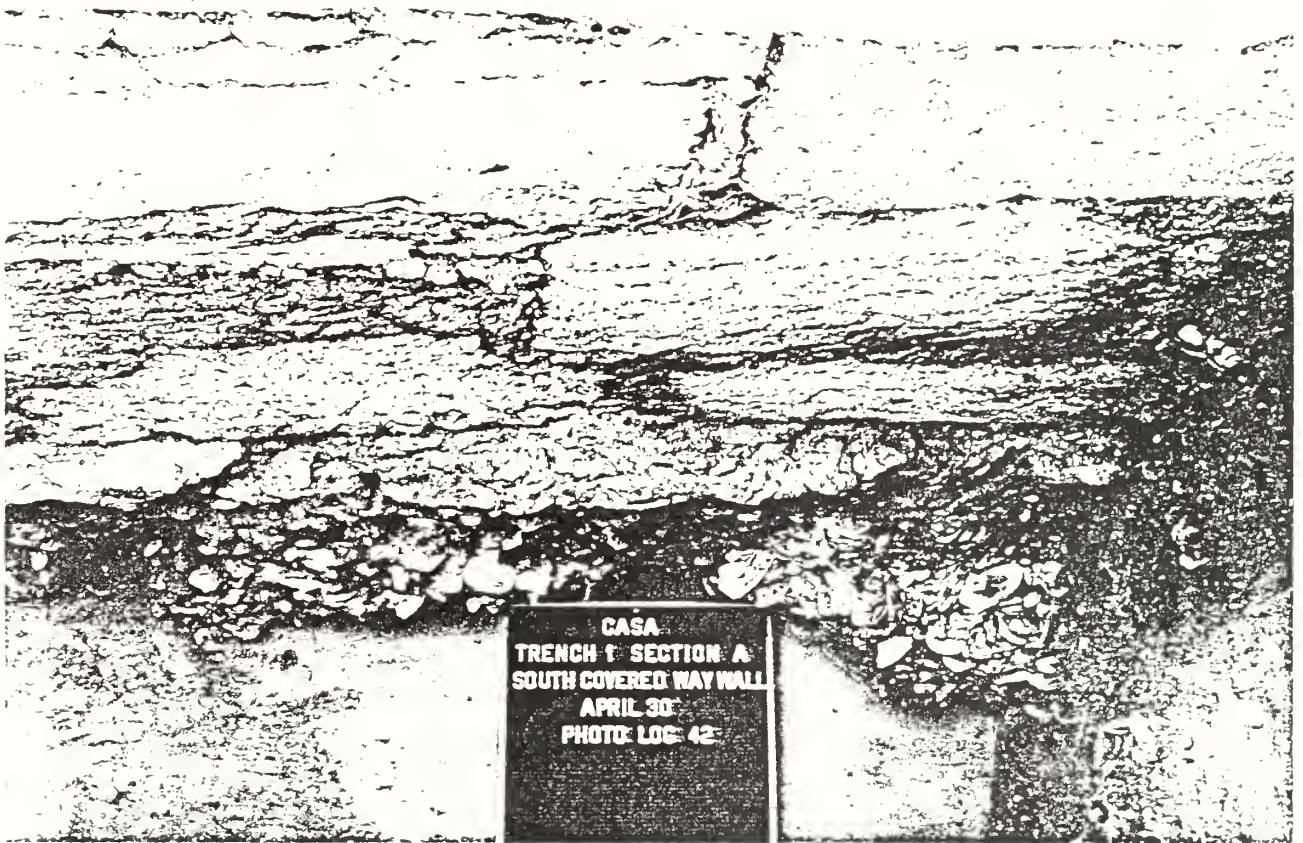
FIGURE 4

South Covered Way Wall - North Elevation

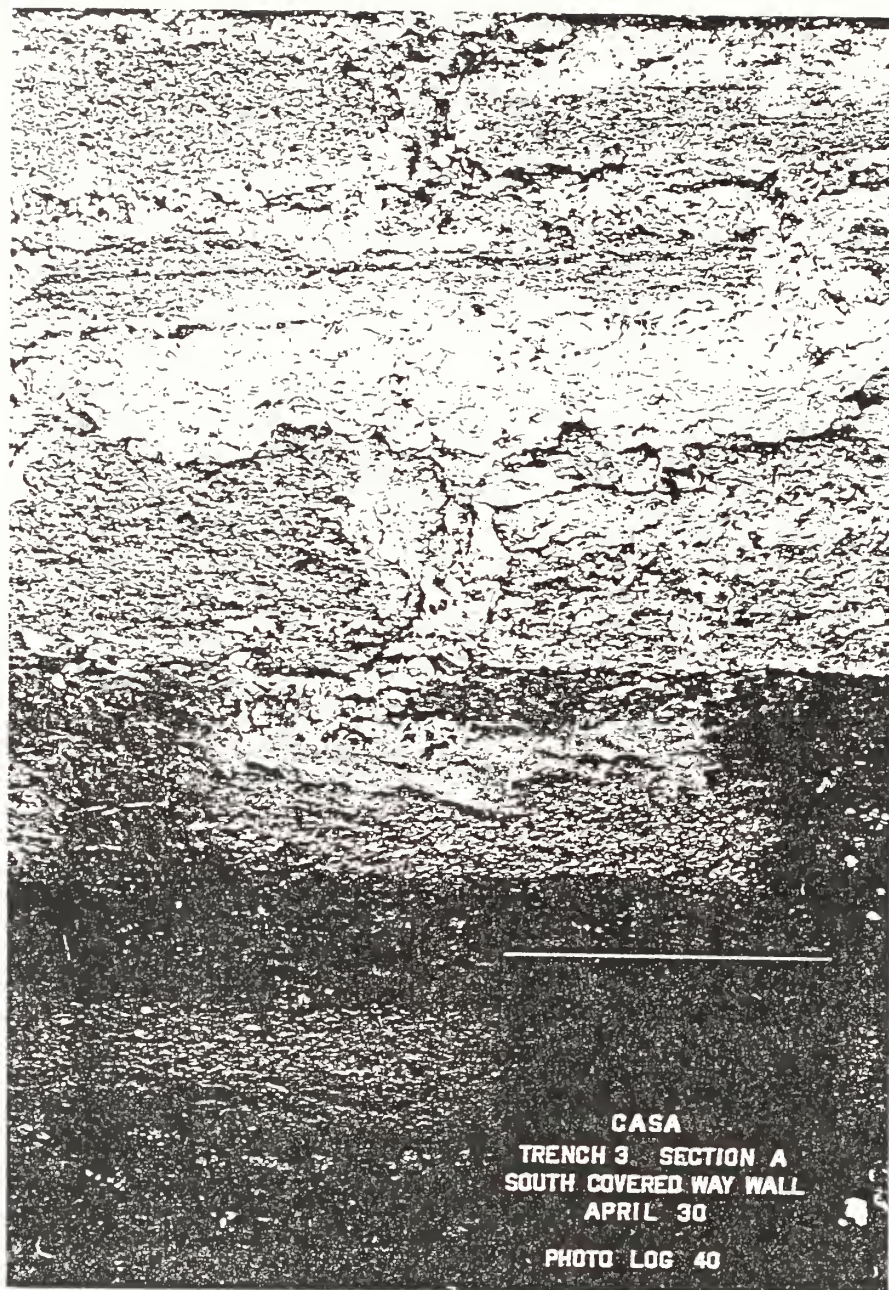
FIGURE 6

Excavation was carried to a depth of 1.70 meters below ground surface adjacent to the wall. At this point the wall was no longer plastered, suggesting that this was the grade prior to the final construction of the wall. Support for this interpretation is provided by the fact that in 1762, six feet of wall was added on the south covered way (Arana and Manucy 1977:57); and the distance from the top of the extant wall to

South Covered Way Wall - South Elevation  
(Glacis side)

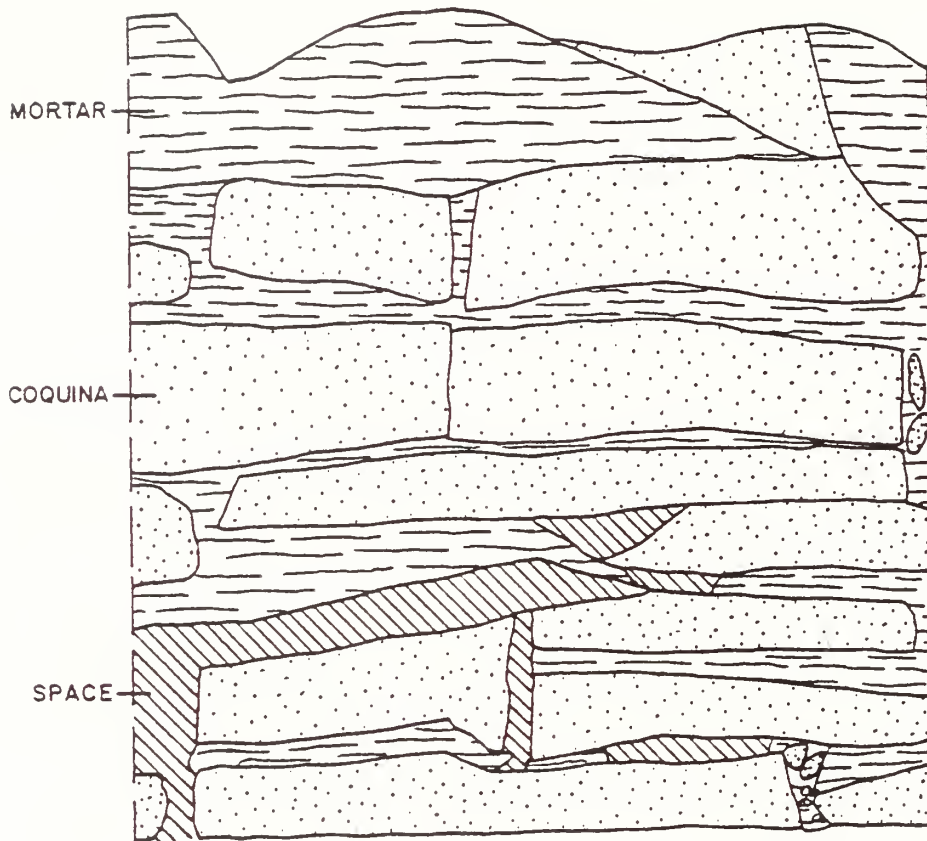
FIGURE 7

Excavations in this unit revealed that the counterscarp wall at the location of the unit (see above) was in stable condition. 8 levels were excavated in this area, to a depth of 2.63 MMSL (1.4 meters below ground surface). Figures 7 and 8 show the face of the counterscarp wall elevation; and Table 5 shows the distribution of artifacts in the fill.

South Covered Way, Trench 2, Section A  
Counterscarp wall, North Face

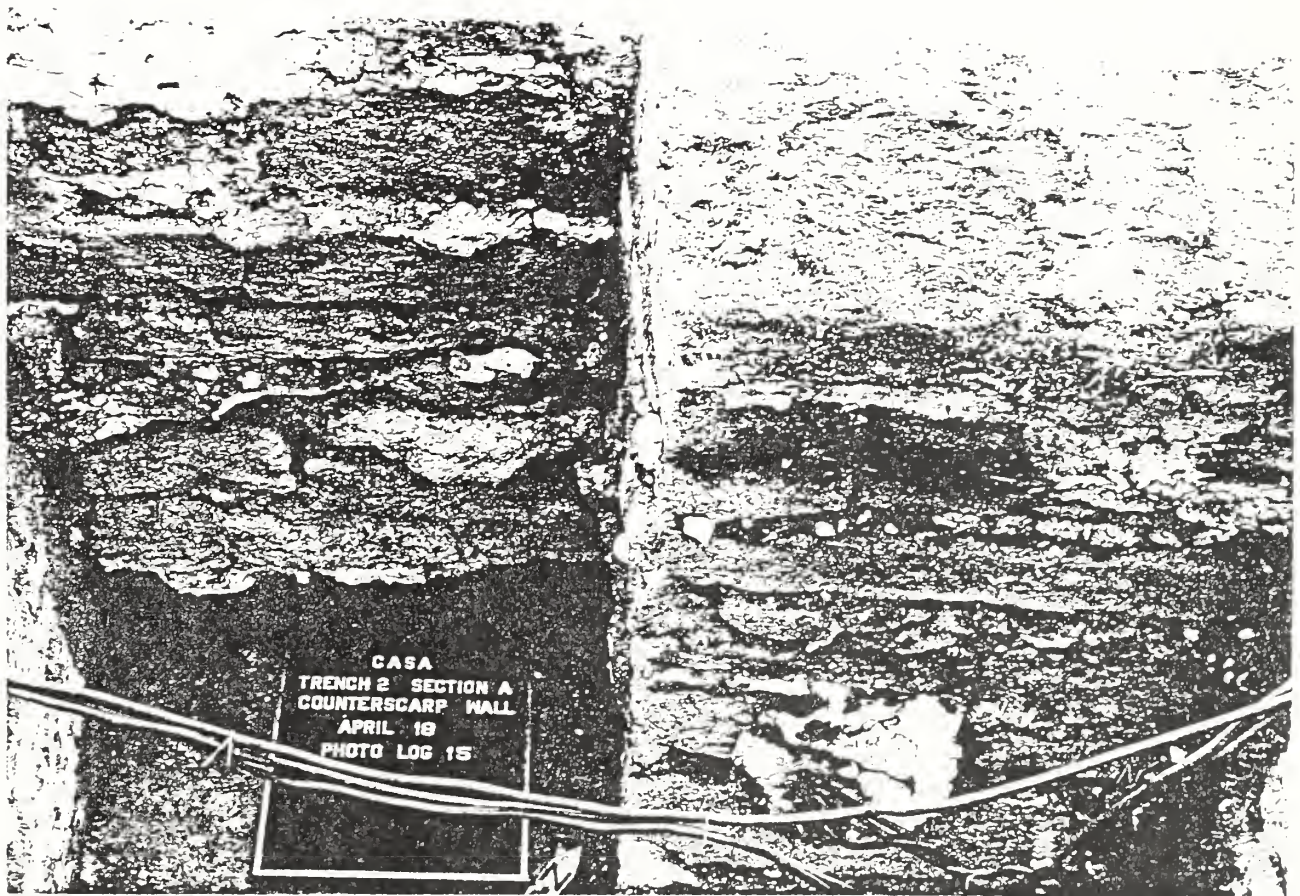
FIGURE 8  
Counterscarp Wall - South Face

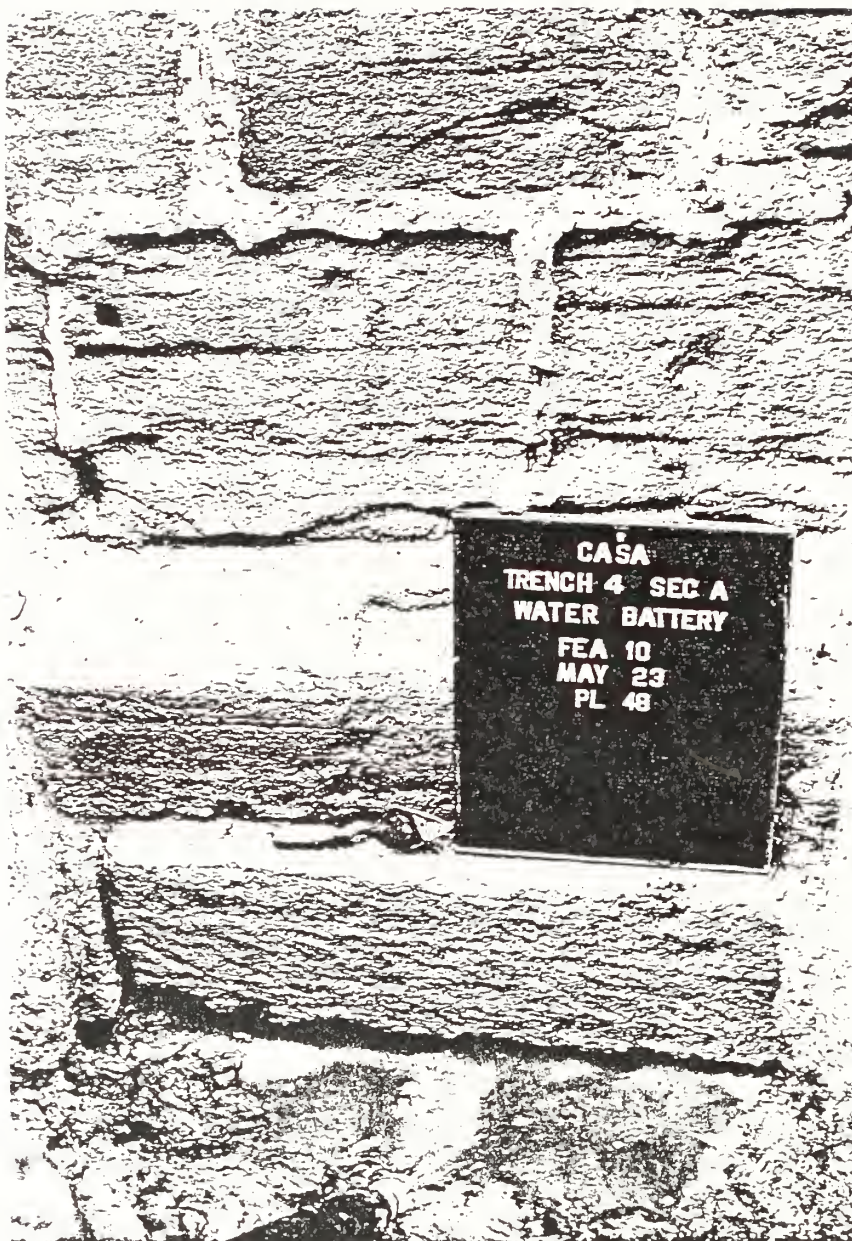
FIGURE 17

Sub-grade foundation of scarp in Water Battery

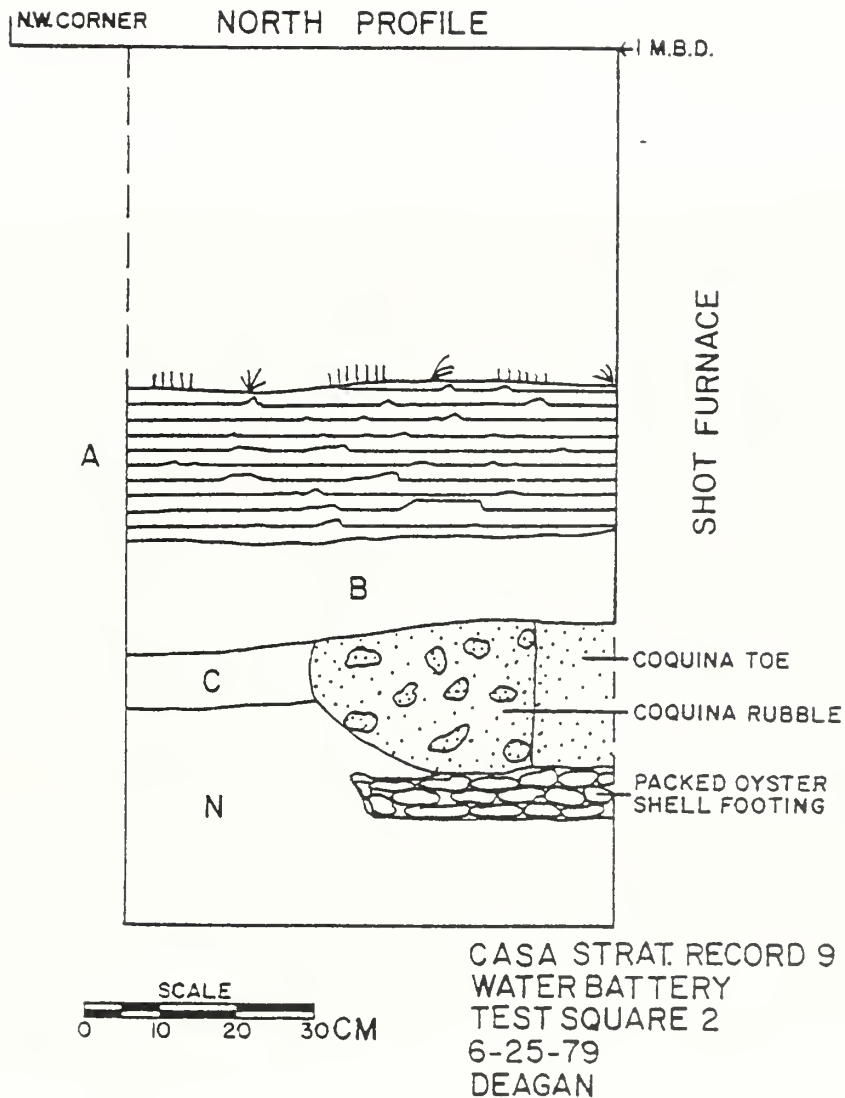
FIGURE 18

Figures 18 and 19 show the base of the shot furnace. At 2.09 MMSL (31 cm. below present surface) a coquina toe was uncovered at the southwest corner of the furnace. This was 20 cm. thick, and extended out from the furnace vertical wall for 10 cm. Adjacent to the solid toe was a deteriorated mass of coquina which was quite likely at one time a part of the toe. It was of the same thickness, and extended an additional 30 cm. out from the solid portion of the toe. Underlying both the solid and deteriorated portions of the toe is a thin footing of packed oyster shells, 10 cm. thick. This rests on the tan fill zone also encountered in Trench 1. The shot furnace was not excavated deeper than the shell footing. Directly above the coquina toe (Feature 13) in Zone 2, Level 2, a 1907 penny was found, indicating that the level was disturbed and filled subsequent to that date.

Water Battery, Test Square 2  
North Profile (Shot Furnace Base)

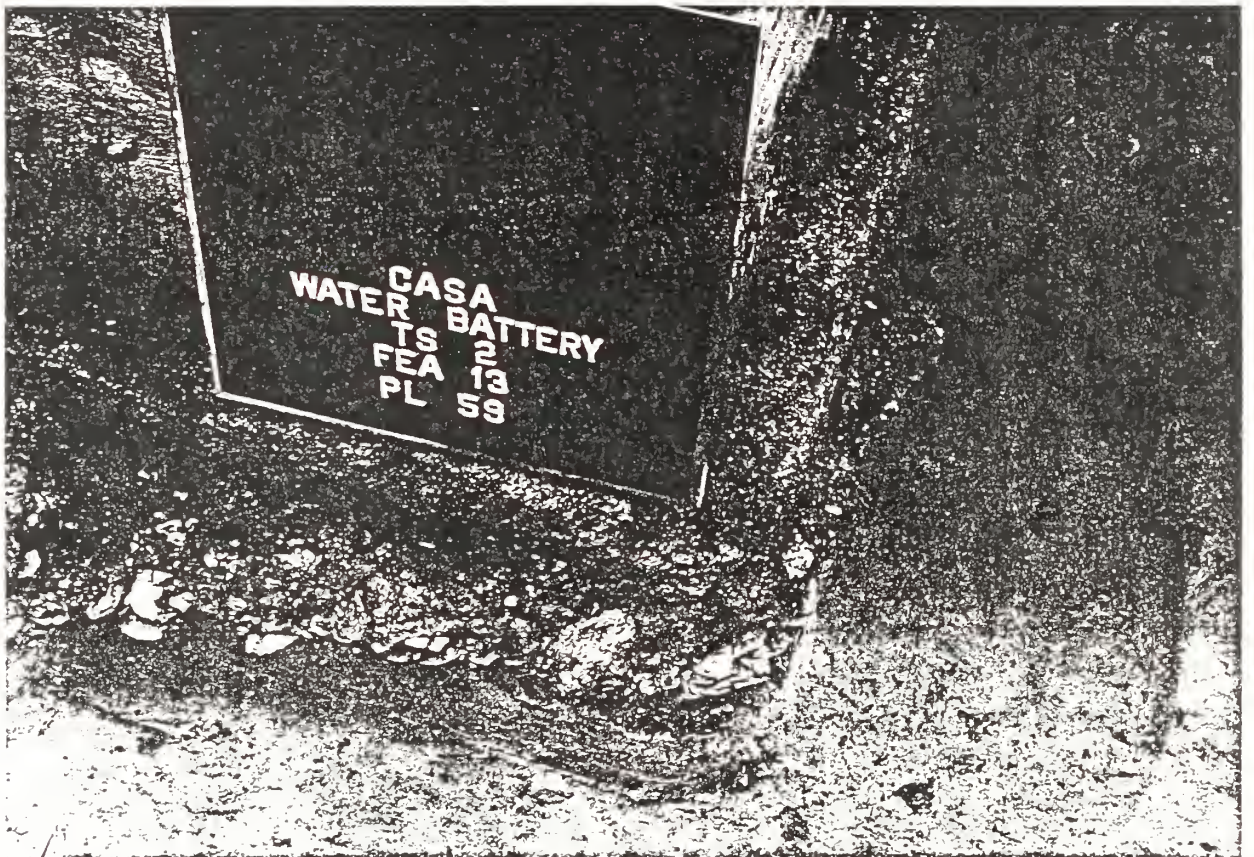
FIGURE 19

Shot furnace Sub-grade foundation

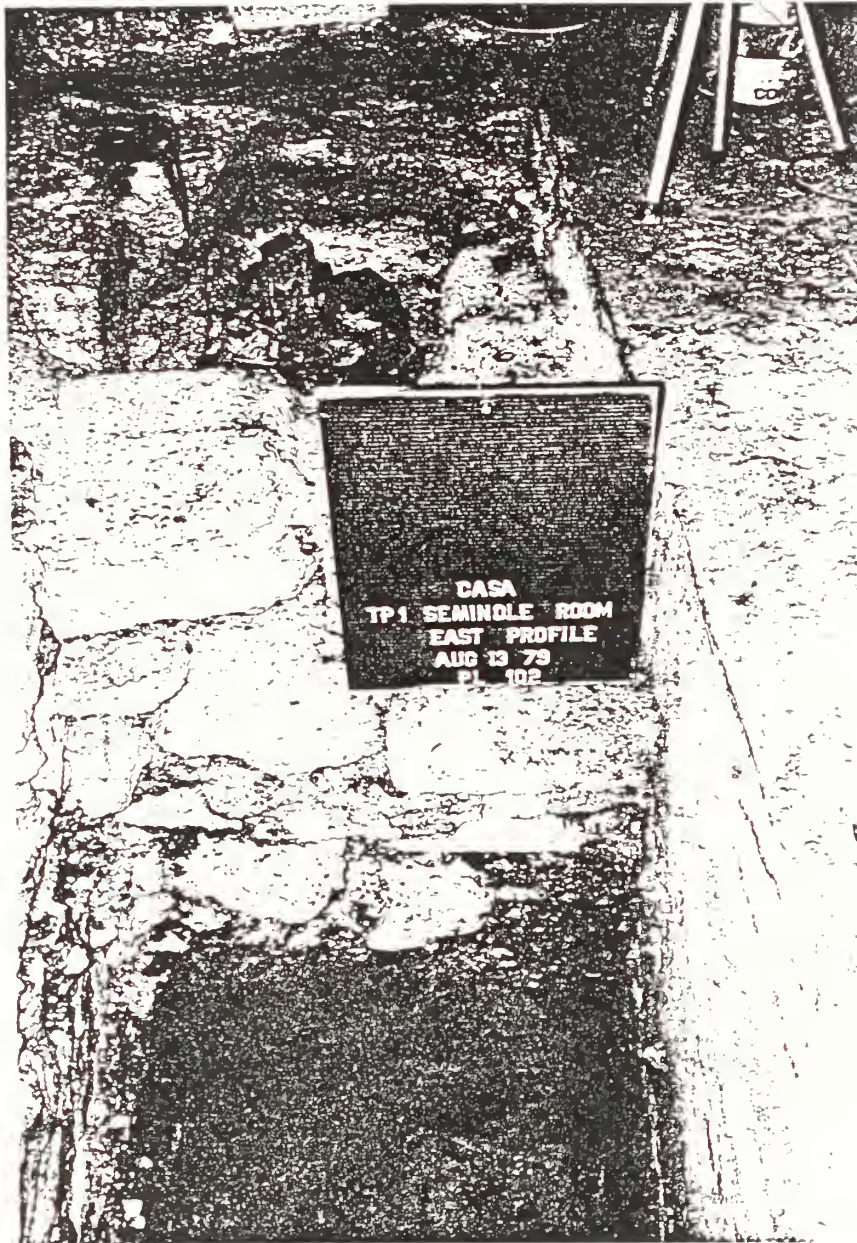
FIGURE 36

Areas 4, 5 and 6 in Test Pit 1 (see Table 23) were irregular areas of discolored and rubble containing soil adjacent to the west side of Feature 21. These areas, ranging from a maximum top elevation of 3.15 MMSL to a maximum base elevation of 1.80 MMSL are also believed to be related to the con-

Seminole Room, Test Pit 1, Features 20 and 21

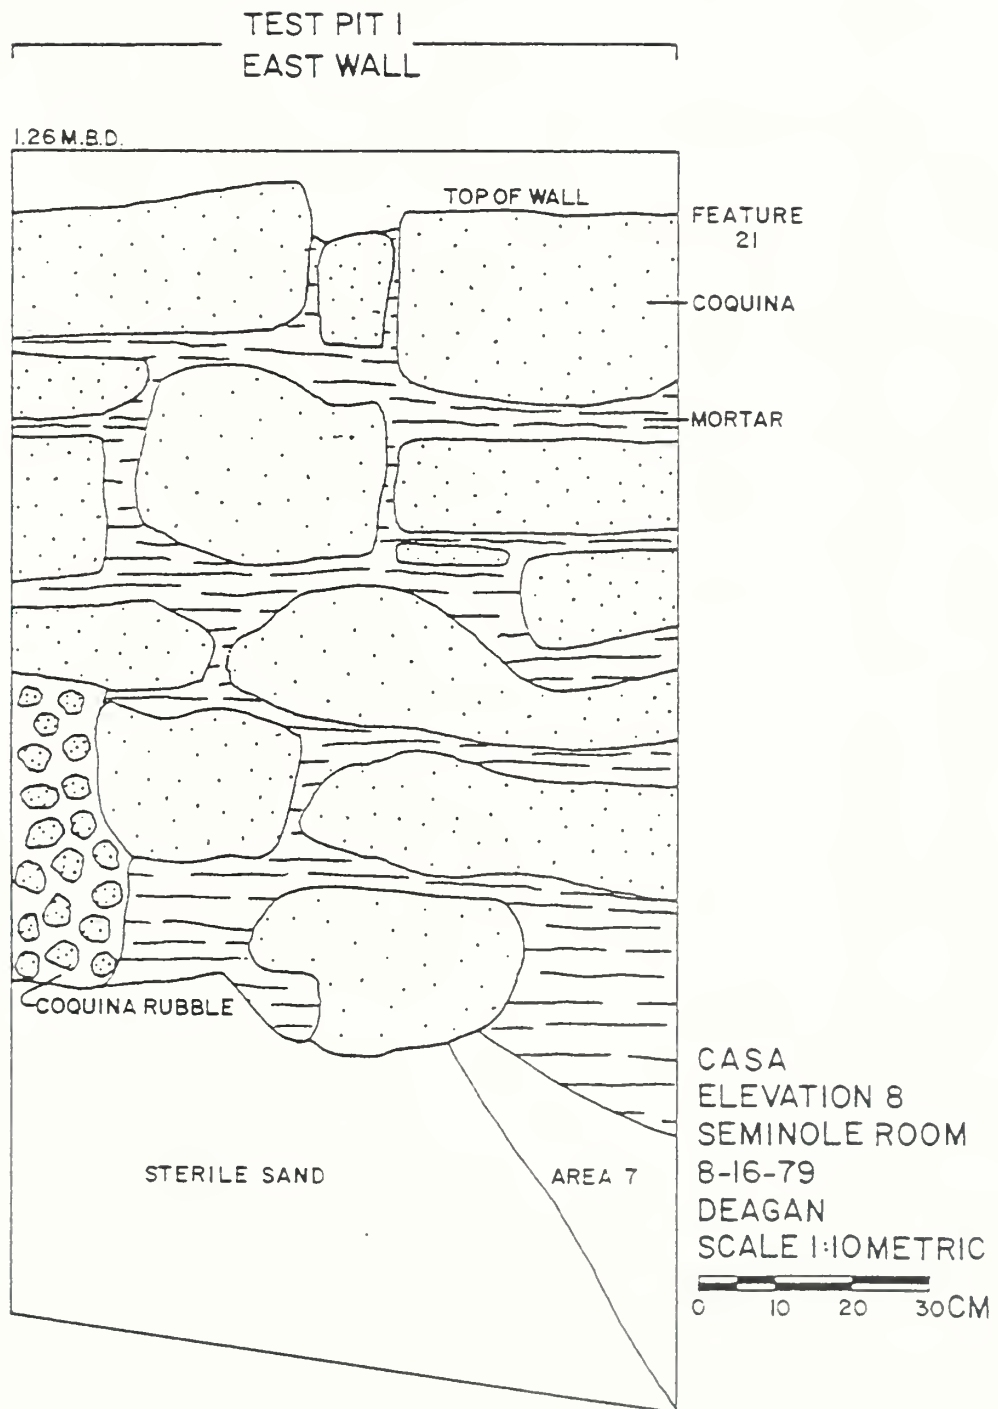
FIGURE 37

Seminole Room, Test pit 1, Feature 21 West face

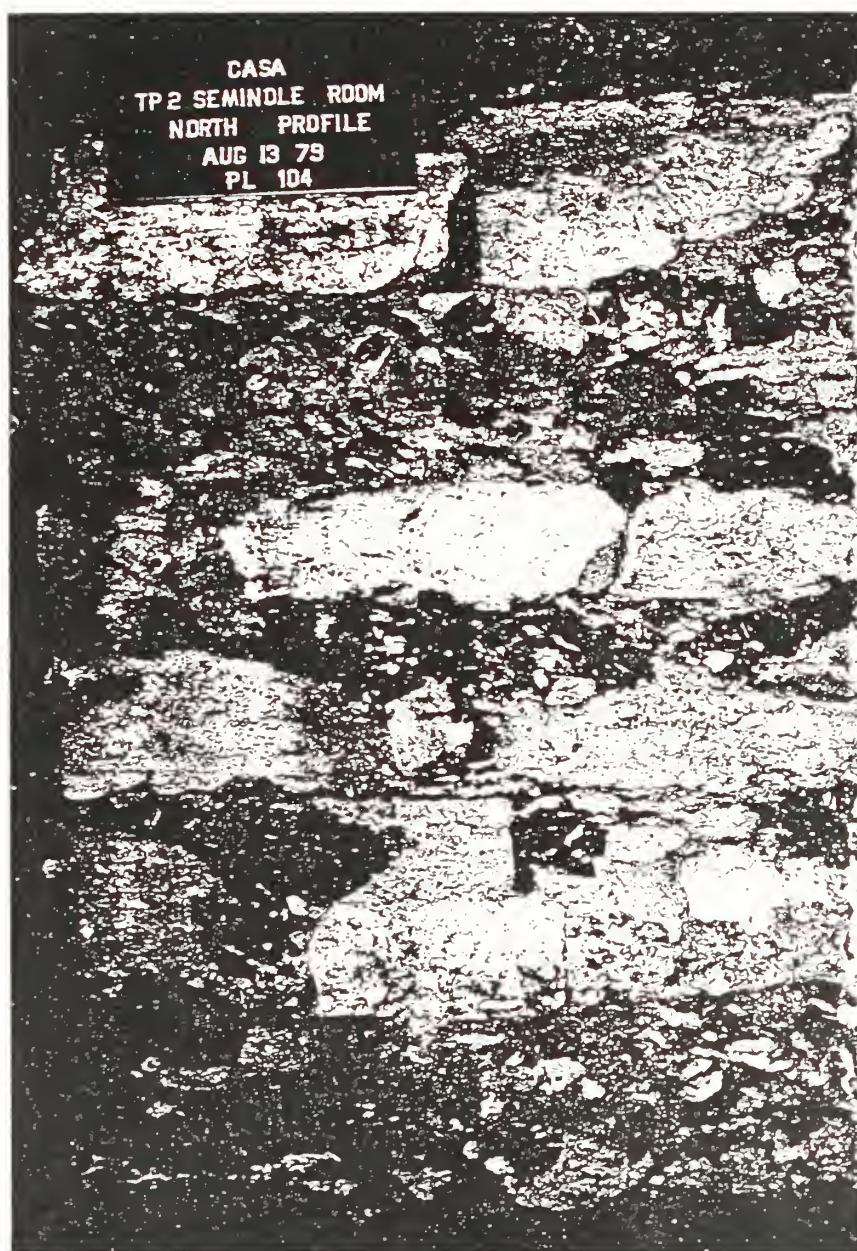
FIGURE 38

The rebuilding of the north wall of the room is evidenced by Feature 20, a coquina and mortar ledge extending for .20 meters out (to the south) of the present north wall (Fig. 38). The top of this ledge is at 3.38 MMSL (4 cm.

Seminole Room, Feature 20 (Ledge along room's  
north wall)
